# **Groundwater Training Course**

**SOPAC, April 2005**

## **Borehole Monitoring Case Studies**

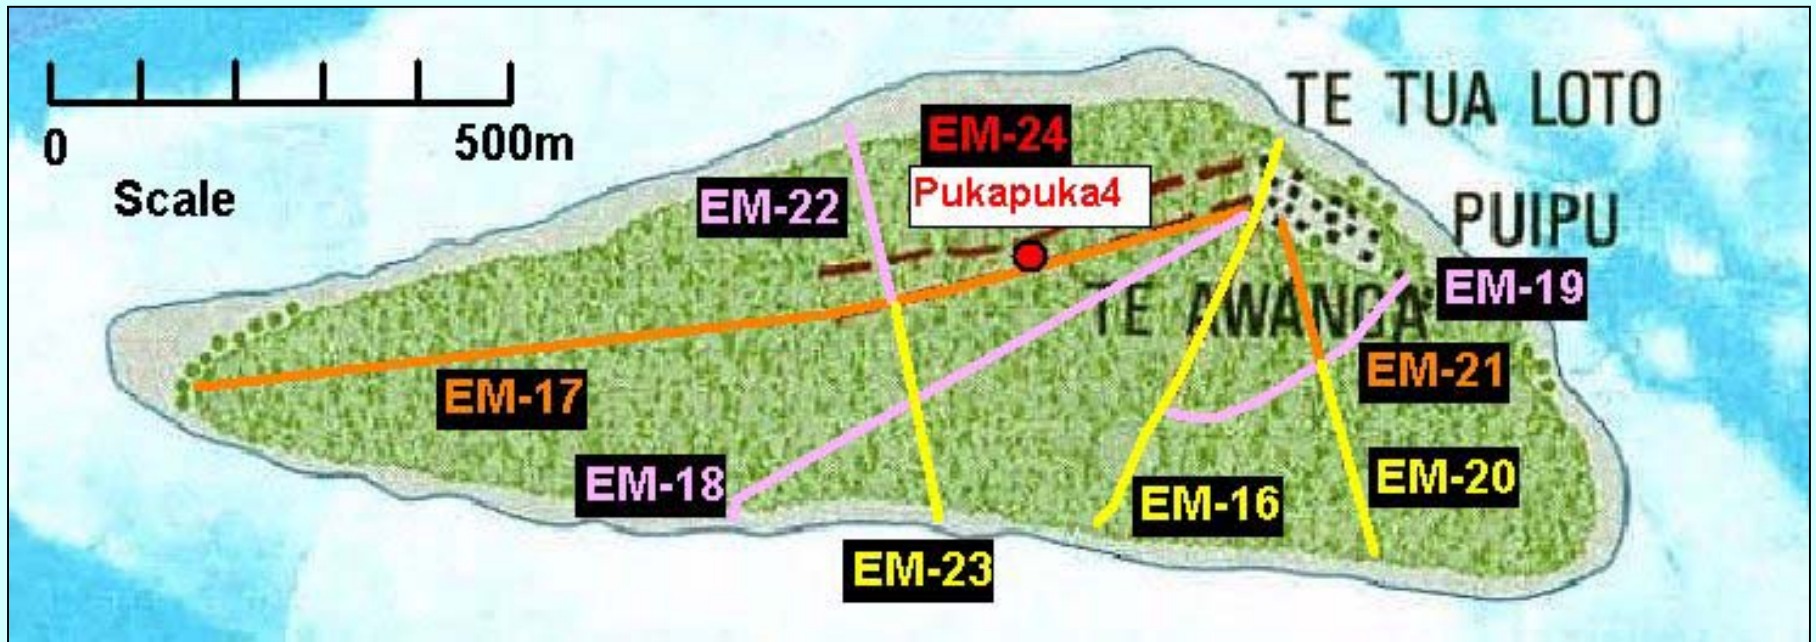
## Borehole Pukapuka4 on Motu Kotawa

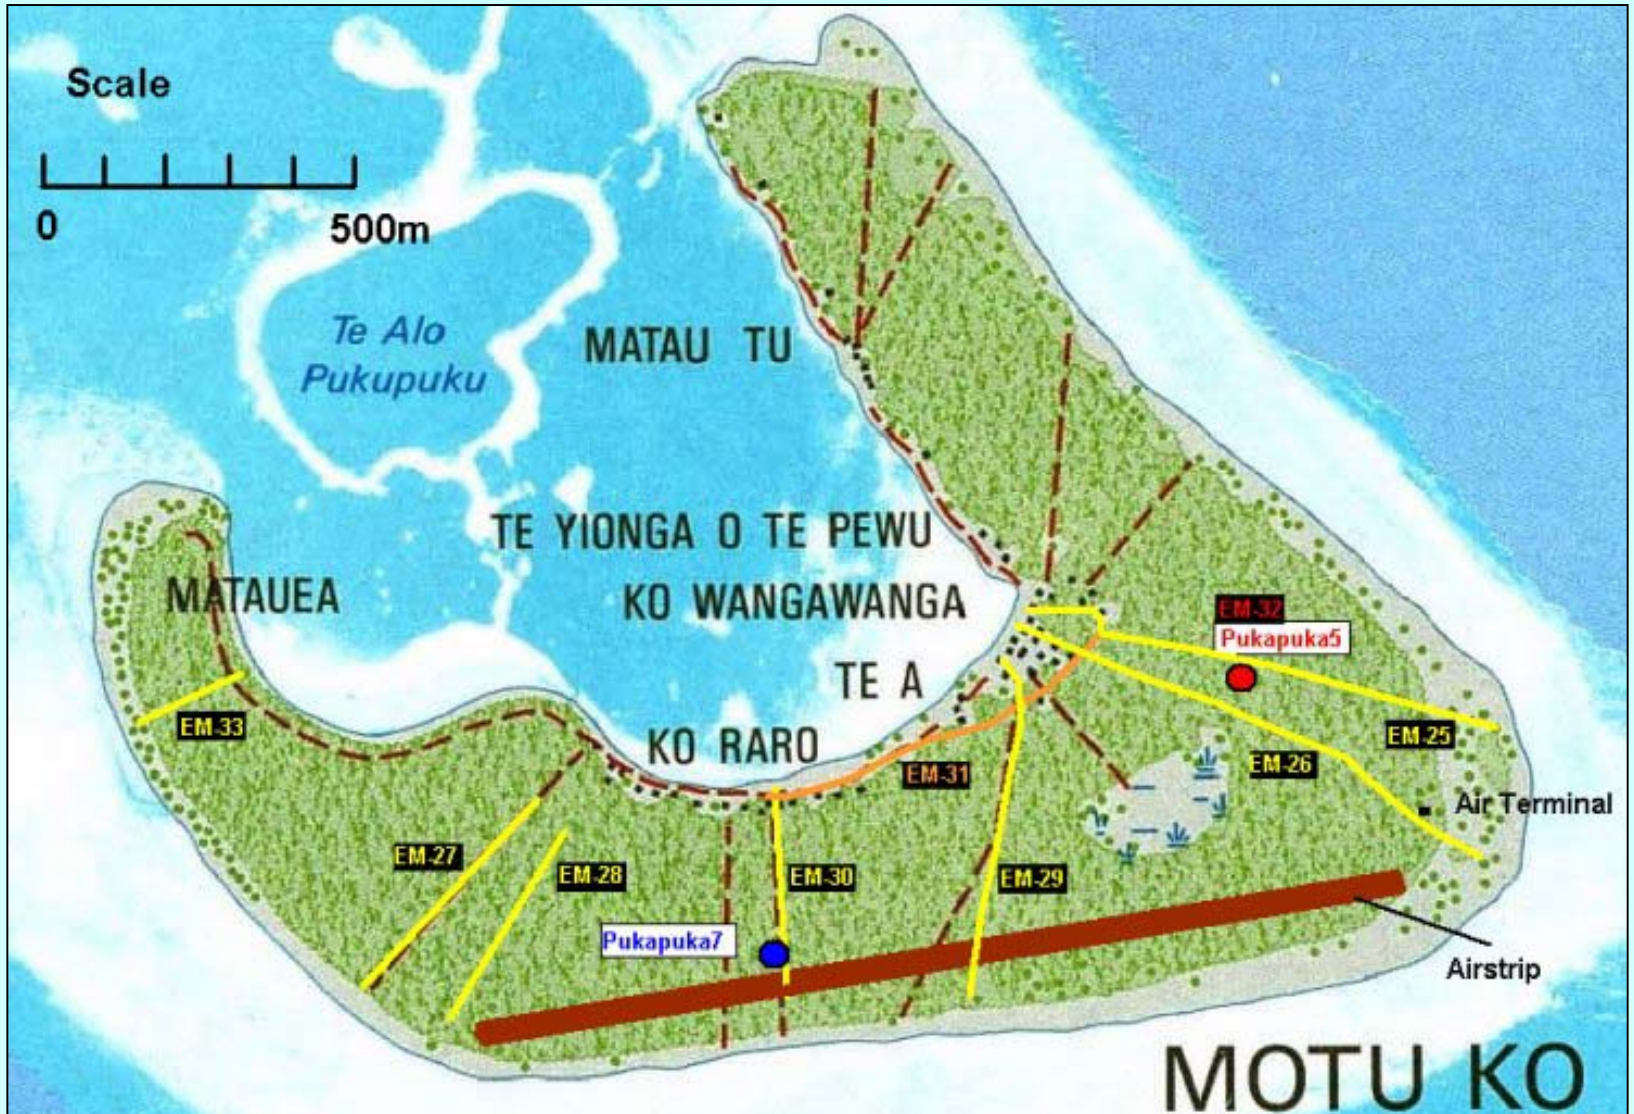
## Borehole Pukapuka5 on Motu Ko

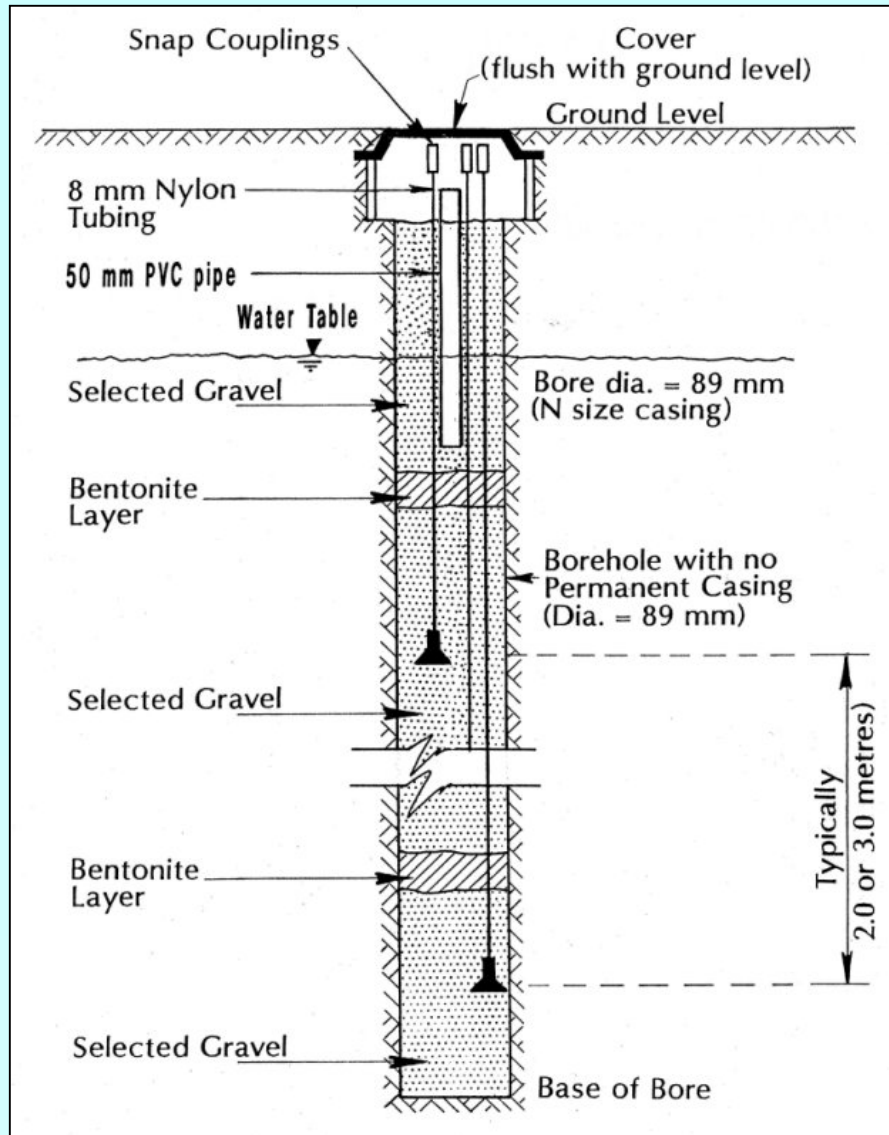
# Borehole Type: multi-level tube system

# Pukapuka monitoring boreholes – summary details

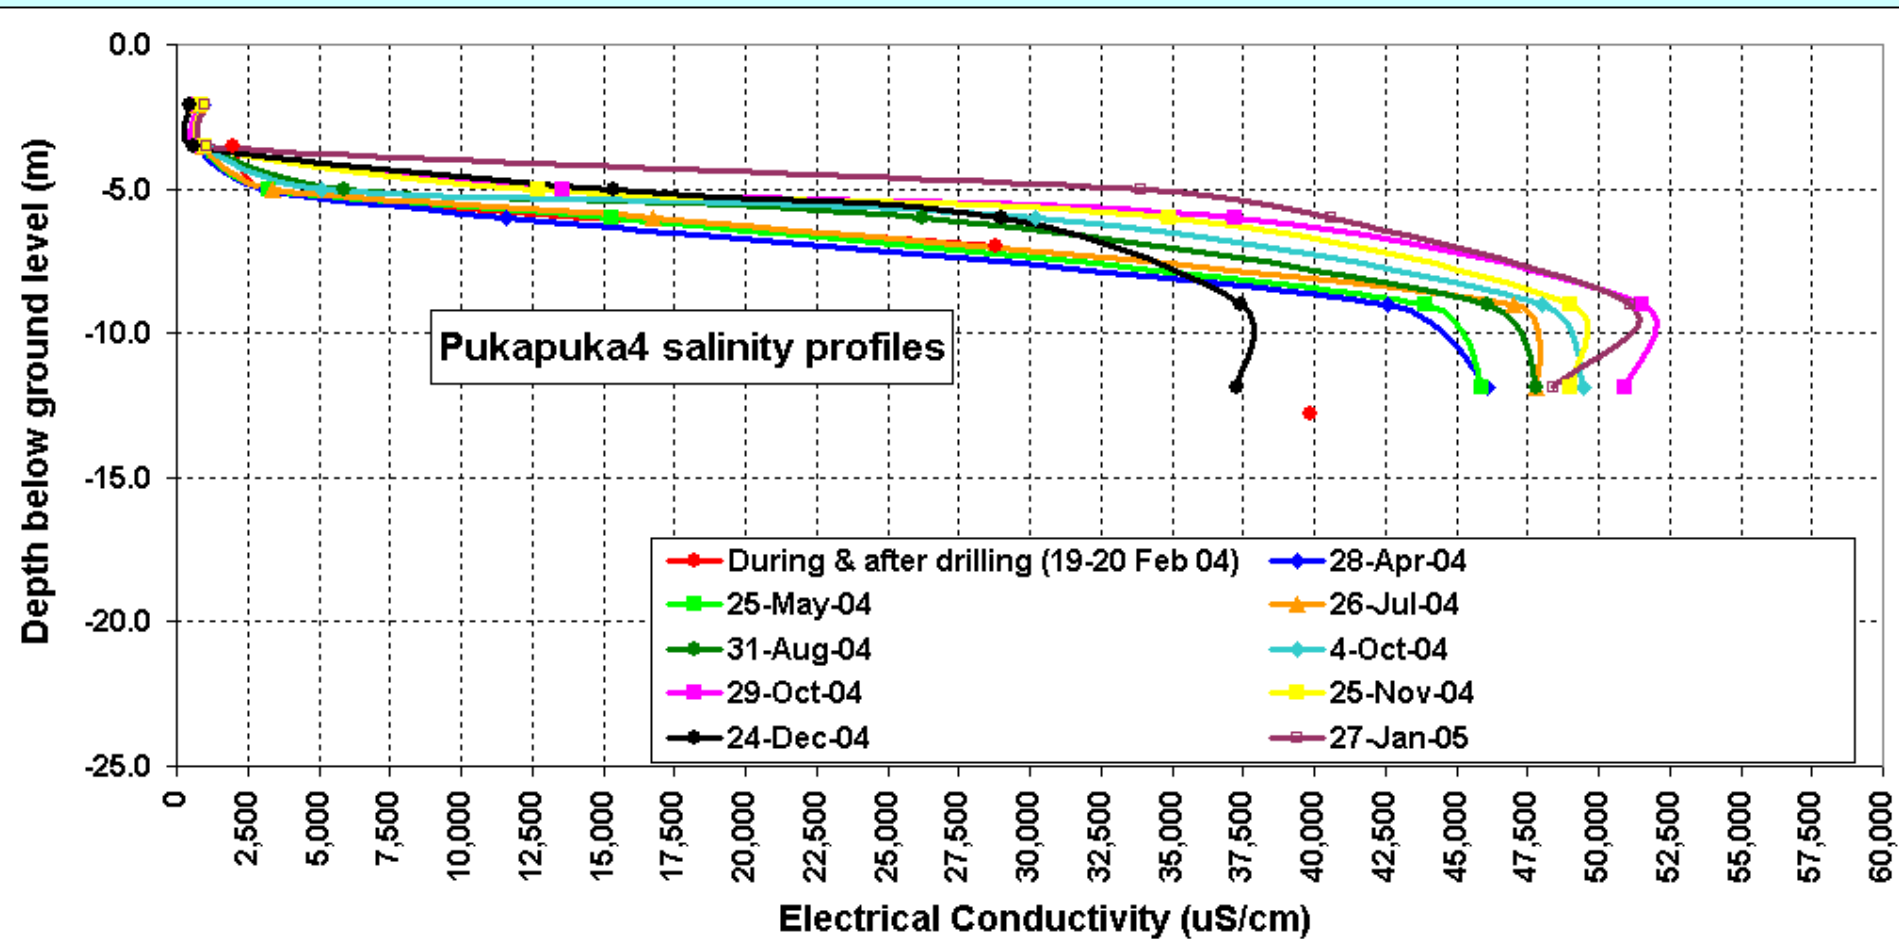
# Borehole Pukapuka4 – salinity profiles, Feb 2004 – Jan 2005

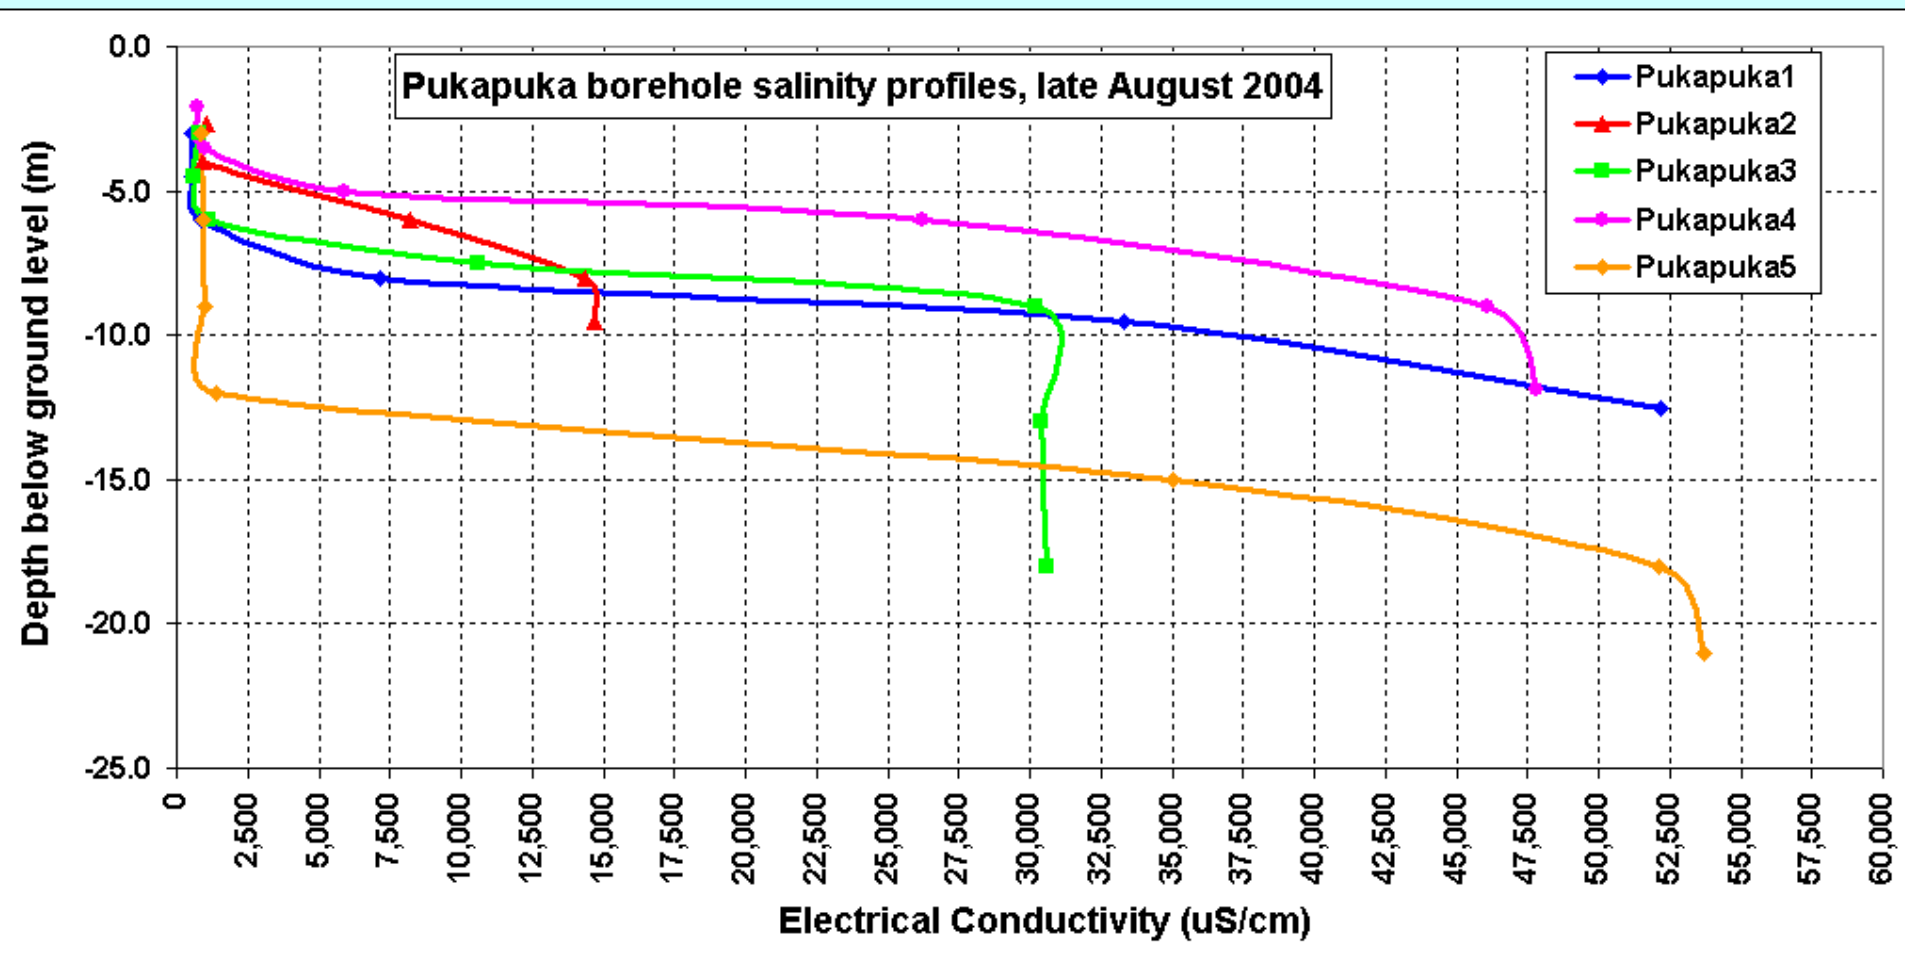
# Boreholes Pukapuka 1 to 5, salinity profiles for selected date (August 2004)

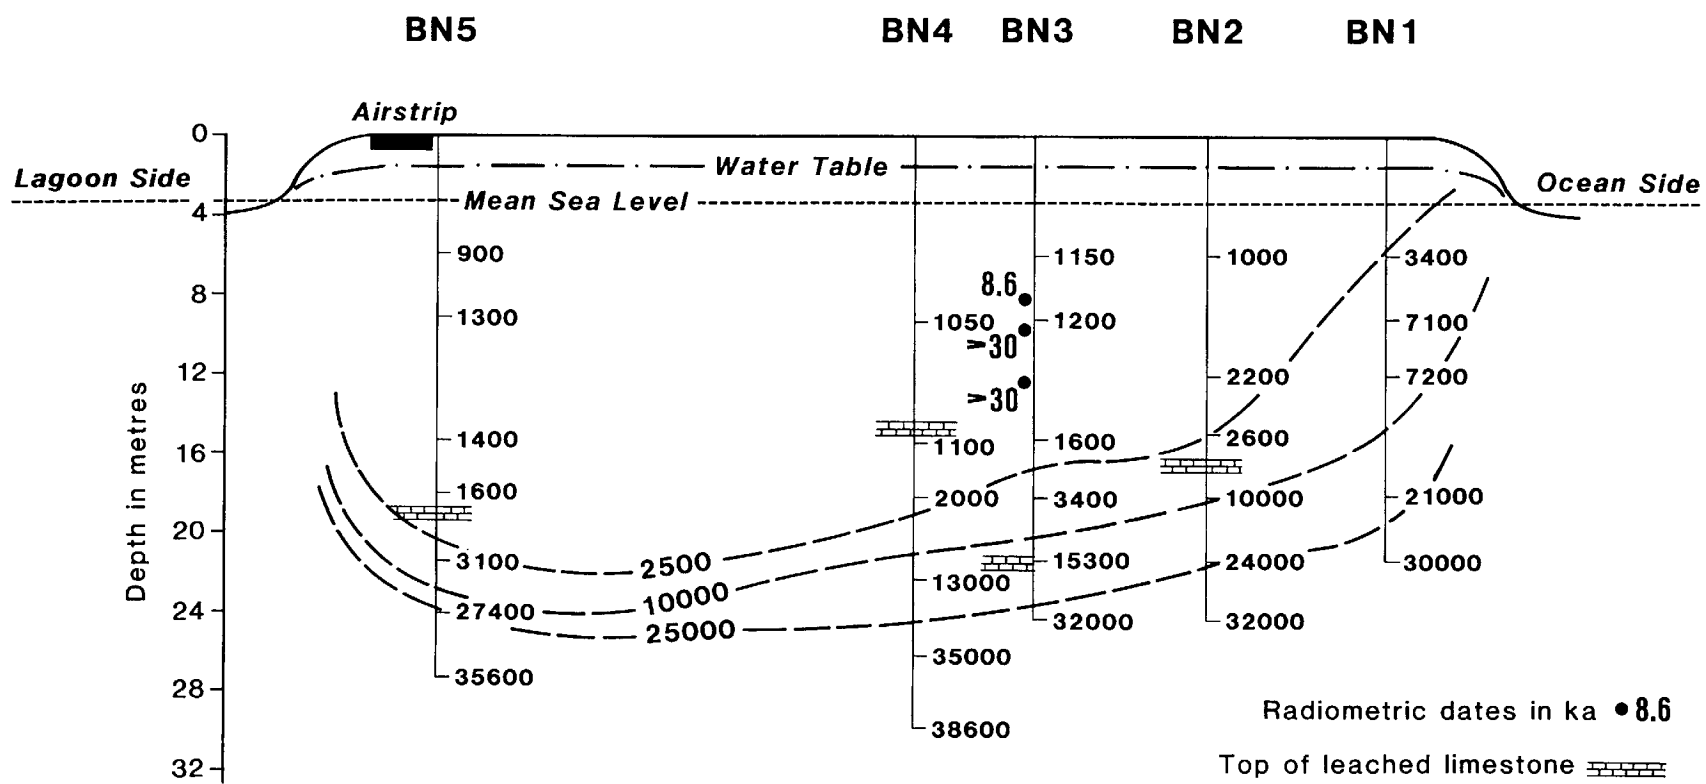
# Bonriki – cross section through lens showing contours of EC (salinity) at boreholes BN1 – BN5

Radiometric dates in ka • 8.6

Top of leached limestone

Borehole BN3 corresponds to borehole I on Fig.1

Isolines of electrical conductivity ( $\mu\text{mhos cm}^{-1}$ ) — 2500 —

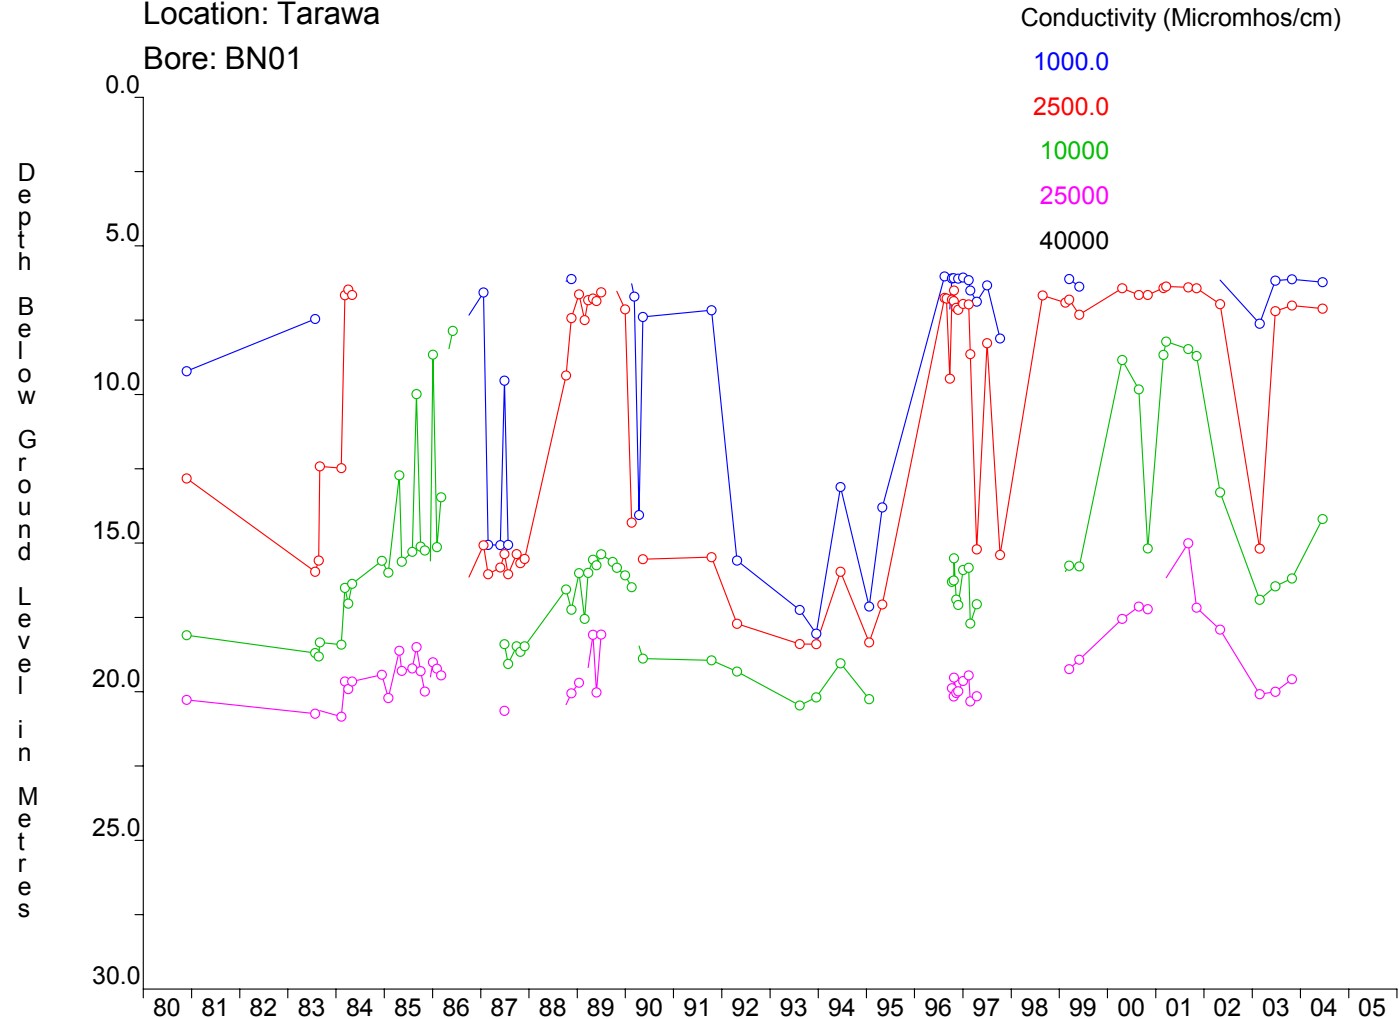
# Bonriki – salinity variations, 1980-2004 at borehole BN1

Electrical Conductivity (25 deg. C.) against Time.

Bore: BN01

**Note: The record from BN1 is one of the longest for Bonriki (and for any atoll island).**

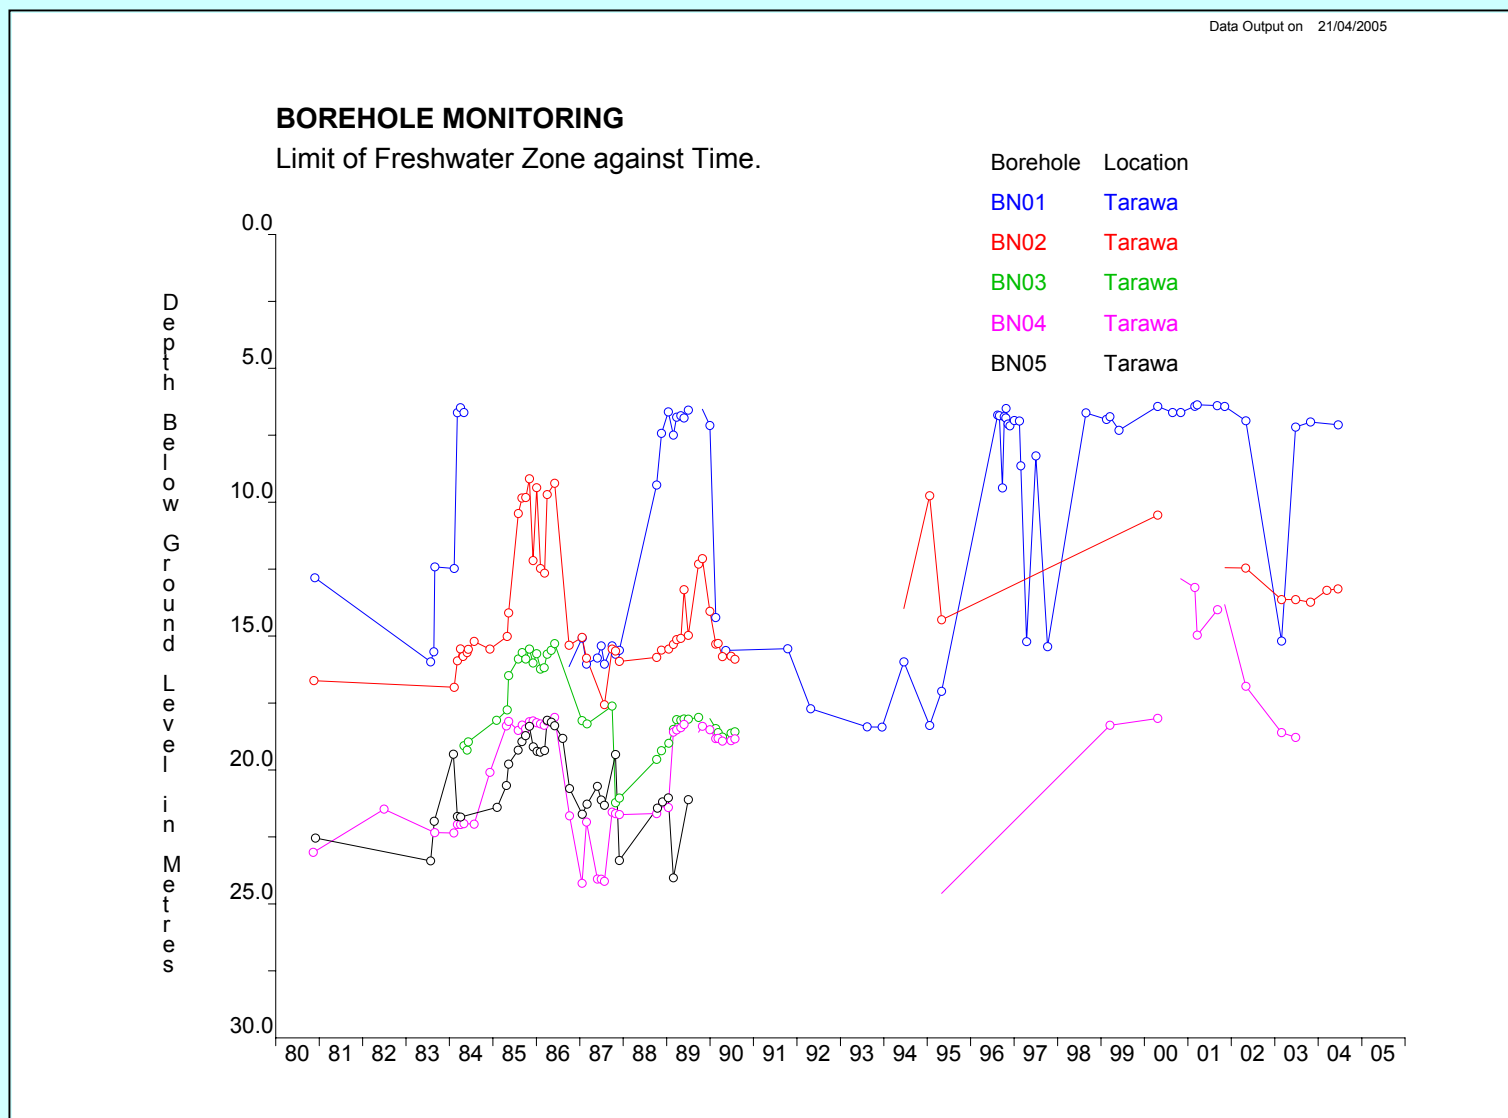
# Bonriki – variations in freshwater zone base, 1980-2004 at boreholes BN1-BN5

**Notes: Some boreholes have been lost or damaged due to runway construction (BN5) or vandalism (BN3). BN2 and BN5 have been rehabilitated. BN1 is the only one not damaged.**
